fathom

June/July 1990

Surface Ship and Submarine Safety Review

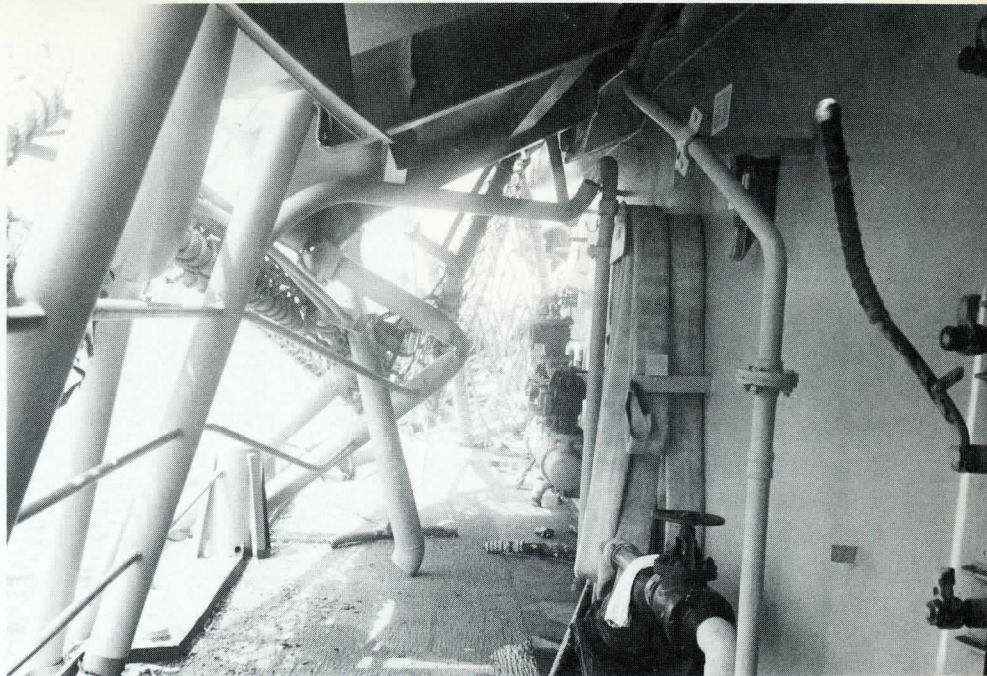
The collision damaged an officers' overflow berthing compartment, injuring five personnel. Two CPOs asleep in the compartment were sucked into the sea, followed by two who jumped. All four were picked up within 20 minutes by the destroyer's motor whaleboat. A corpsman treated them for inhalation of JP-5 fuel and other injuries that occurred while in the water. The fifth chief evacuated the space by climbing onto the main deck through the hole.

The collision resulted in both external and internal damage to the destroyer, as evidenced in the photos at the top and bottom of this page.

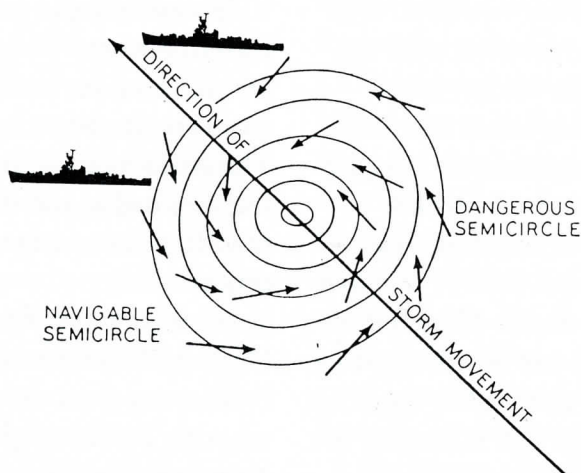
Figure 2. A ship hove-to in the dangerous semicircle will note the wind to shift to the right (clockwise); the wind will shift to the left (counterclockwise) if the ship is in the navigable semicircle.

b. If the ship is in the safe or navigable semicircle, bring the wind on the starboard quarter (130 degrees R) and make the best speed.

c. If in the dangerous semicircle, bring the wind on the starboard bow (45 degrees R) and make as much headway as possible. ■

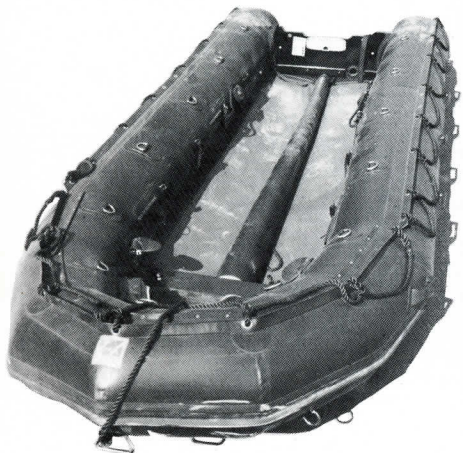
A lance corporal tossed from his boat by the seas was rescued by two more boats, which both capsized. Equipment-securing lines creating a spider-web effect, trapped the lance corporal beneath the third boat and caused him to drown. A sergeant, the senior NCO in the boat, recovered the lance corporal and unsuccessfully tried to revive him with cardiopulmonary resuscitation.

The Marines used Combat Rubber Raiding (CRRCs) pictured left when the situation called for them to use Rigid Raiding Craft (RRCs) bottom.
