fathom

June/July 1990

Surface Ship and Submarine Safety Review

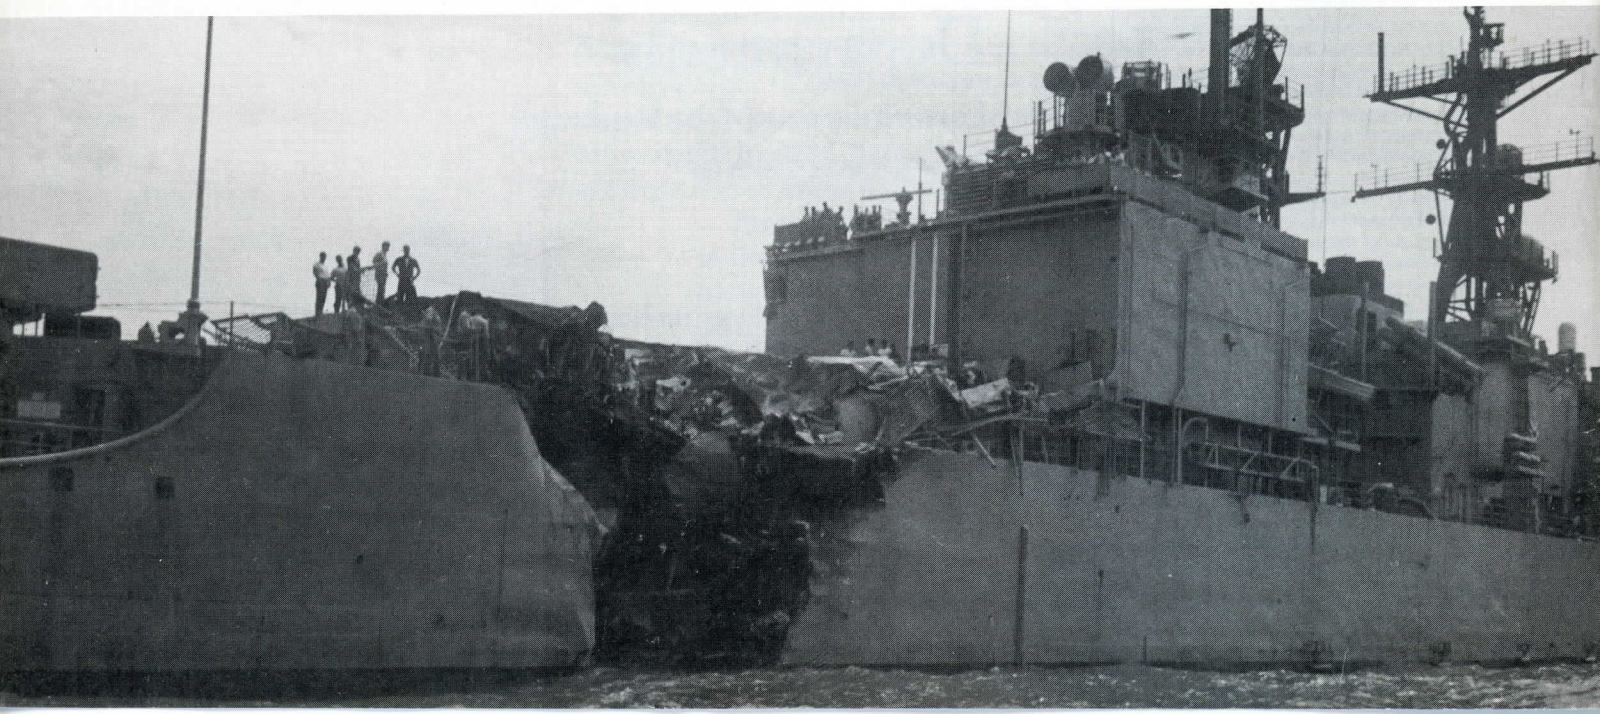
(Bottom, left) Destroyer crewmen survey the \$20 million worth of damage to their ship. (Left) The crippled tanker rests at anchorage.

Damage to the destroyer included six spaces destroyed, two magazines destroyed and five spaces flooded. In addition, the ship lost 25 percent of its onboard supplies. The collision also resulted in major damage to the helo deck and its RAST recovery system.

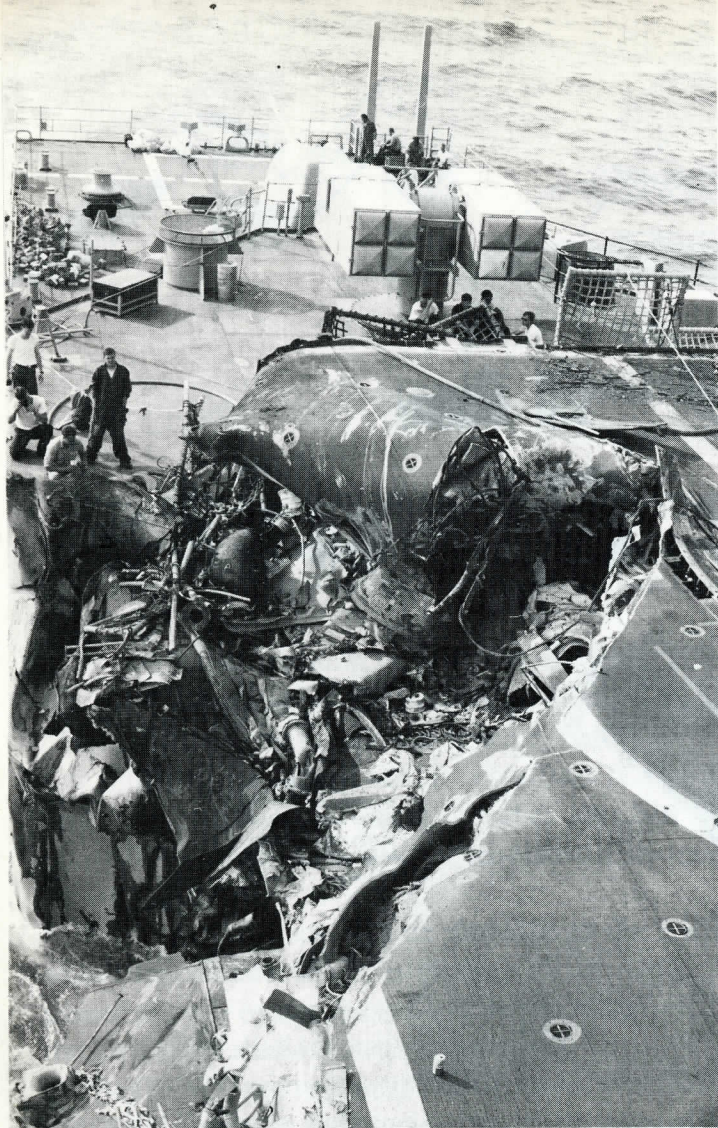
The collision resulted in both external and internal damage to the destroyer, as evidenced in the photos at the top and bottom of this page.
